DEPARTMENT OF TRANSPORTATION**DIVISION OF ENGINEERING SERVICES**

Contract #: 04-0120F4Cty: SF/ALA Rte: 80 PM: 13.2/13.9File #: 69.28**WELDING INSPECTION REPORT****Resident Engineer:**Siegenthaler, Peter**Address:** 333 Burma Road**City:** Oakland, CA 94607**Report No:** WIR-022473**Date Inspected:** 05-Apr-2011**Project Name:** SAS Superstructure**OSM Arrival Time:** 700**Prime Contractor:** American Bridge/Fluor Enterprises, a JV**OSM Departure Time:** 1900**Contractor:** Zhenhua Port Machinery Company, Ltd (ZPMC), Changxing Island **Location:** Shanghai, China**CWI Name:** Liu Hua Jie.**CWI Present:** Yes No**Inspected CWI report:** Yes No N/A**Rod Oven in Use:** Yes No N/A**Electrode to specification:** Yes No N/A**Weld Procedures Followed:** Yes No N/A**Qualified Welders:** Yes No N/A**Verified Joint Fit-up:** Yes No N/A**Approved Drawings:** Yes No N/A**Approved WPS:** Yes No N/A**Delayed / Cancelled:** Yes No N/A**Bridge No:** 34-0006**Component:** OBG components.**Summary of Items Observed:**

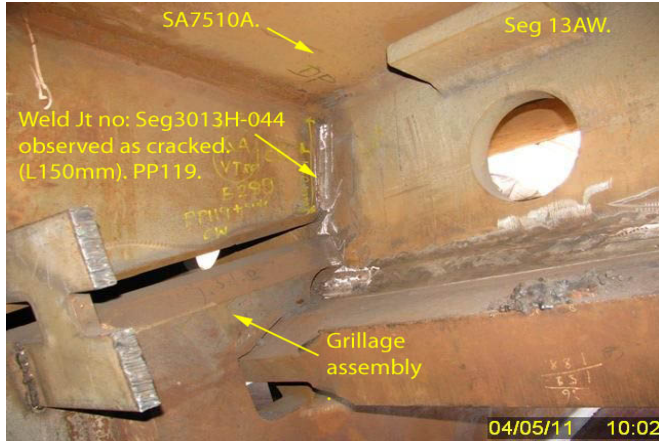
This QA Inspector observed that the weld jt: Seg3013H-044 [Deck Panel (DP) diaphragm of SA7510A to RS stiffener of SA7510A, CJP weld, at PP119] is cracked to its complete length (L150mm). This QA Inspector notified the ZPMC QC, identified as Shen Jian Bo. ZPMC QC agreed to make Critical Welding Report (CWR) before this weld is removed and re-welded. See attached photo for further details. This QA Inspector notified the CT Lead Inspector of this incident as documented in this report.
